DESIGN PARAMETERS OF ROOF SUPPORT SYSTEMS FOR PRE-DRIVEN LONGWALL RECOVERY ROOMS

S. C. Tadolini
T. M. Barczak
NIOSH
Pittsburgh, PA

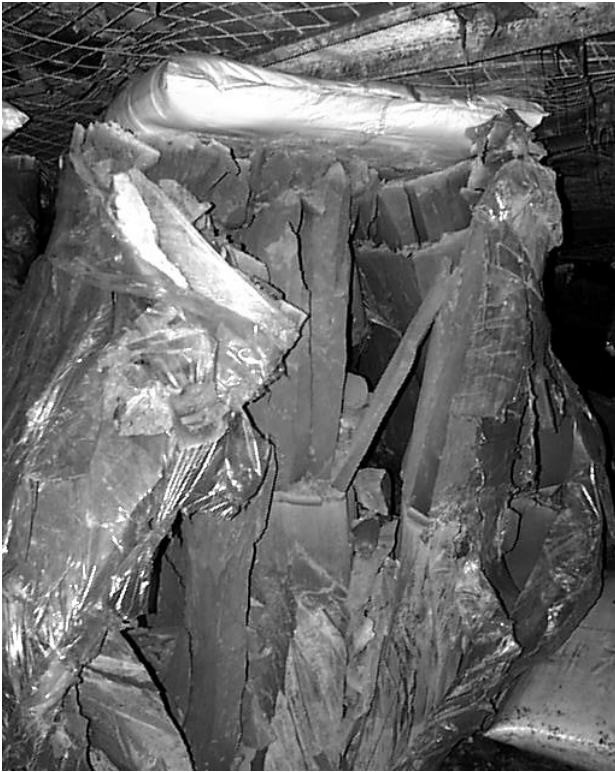
Figure 7. Brittle crib failure prior to the longwall entering the recovery room.

The greatest measured crib load was approximately 1,000,000 lbs. This load, coupled with the crib displacements, results in a stiffness calculation for the concrete crib and the bag of 1.69×10^6 lb/inch. This value is significant because it represents an indication of the resistance to load. While this stiffness helped minimize roof closure and movement, the stiff material

properties may have caused the cribs to fail in a brittle mode as shown in Figure 7.
